Petzl GriGri+ Testing

Date: October 23, 2019

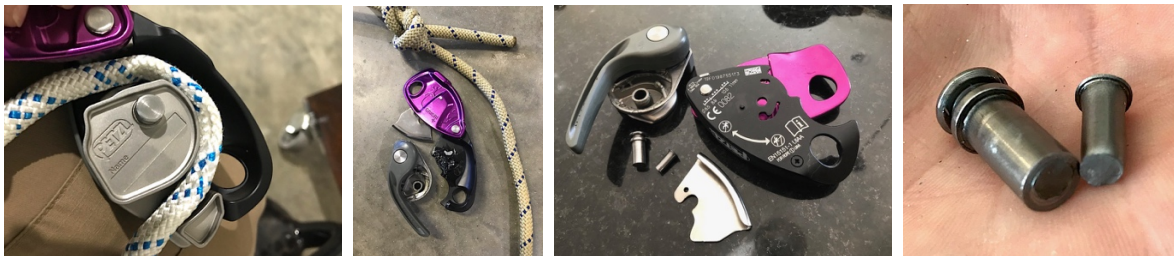
1. 8.3mm Imlay Canyon Fire: slippage occurred at 4.5 kN. Tester could not hold the rope over the brake bar firm enough by hand to keep it from slipping.
2. 9mm Sterling HTP: slippage occurred at 7.75 kN. Tester could not hold the rope over the brake bar firm enough by hand to keep it from slipping.
3. 11mm Bluewater II: Rope did not slip so no brake hand pressure was applied. Catastrophic failure occurred of the GriGri at 10.2 kN. Rope remained intact.

How the GriGri failed:

At 10.2 kN of force the main cam pivot pin sheared off flush at the black side plate that holds the cam in place. This is a step-down pin that is a larger diameter going through the cam, then steps down to .200" where it fastens into the black side plate. The stainless-steel plate that is attached to the anodized side plate (opening plate on the GriGri) also popped off. This plate is used both as a brake bar wear plate (on the outside) and a capture device for the main cam pin (on the inside). Once the plate broke off, the whole cam and rope came out of the main body even though the carabiner was still intact and the unit was still closed and captured by the carabiner. The tests were duplicated on a second GriGri+ with the same results. The second GriGri failed at 10.1 kN.

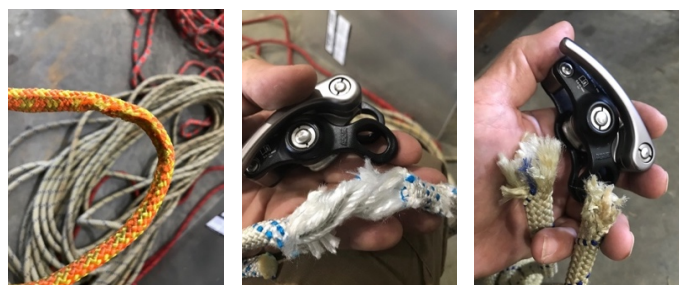
The above tests were applied to a MadRock Safeguard device. The 8.3mm Polyester rope slipped at 4.3 kN and continued to slip. The 9mm HTP rope slipped at 8.5 kN for about 7 inches then started de-sheathing the rope. The 11mm Bluewater Nylon static rope did not slip at all and was finally pinched in two at 12 kN. The Safeguard device suffered no visible damage.
