Petzl GriGri+ Testing

Date: October 23, 2019

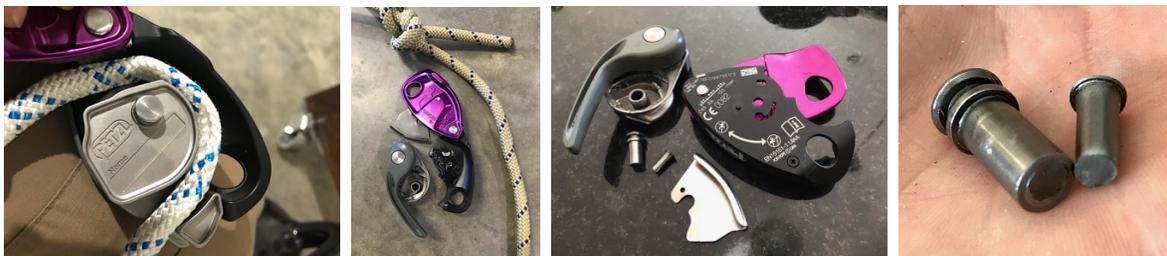
1. 8.3mm Imlay Canyon Fire: slippage occurred at 4.5 kN. Tester could not hold the rope over the brake bar firm enough by hand to keep it from slipping.
2. 9mm Sterling HTP: slippage occurred at 7.75 kN. Tester could not hold the rope over the brake bar firm enough by hand to keep it from slipping.
3. 11mm Bluewater II: Rope did not slip so no brake hand pressure was applied. Catastrophic failure occurred of the GriGri at 10.2 kN. Rope remained intact.

At 10.2 kN of force the main cam pivot pin sheared off flush at the black side plate that holds the cam in place. This is a step-down pin that is a larger diameter going through the cam, then steps down to .200" where it fastens into the black side plate. Once the .200" diameter pin sheared at the plate, it allowed the cam to torque (drop down slightly) inside the body of the GriGri. This torqueing of the cam under load bent the anodized side plate outward (the opening and closing plate) and popped off the stainless plate that is attached to the anodized side plate. The stainless plate is used both as a brake bar wear plate (on the outside) and a capture device for the main cam pin (on the inside). Once the plate broke off, the whole cam and rope came out of the main body even though the carabiner was still intact and the unit was still closed and captured by the carabiner.

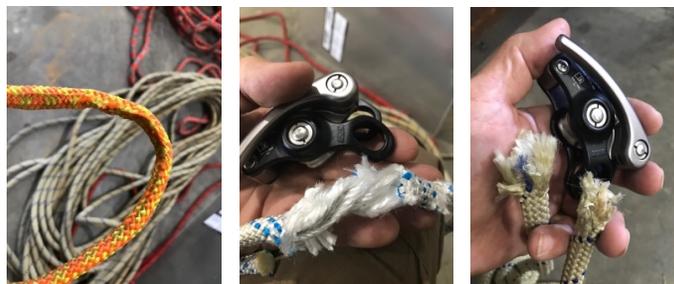
The above tests were applied to a MadRock Safeguard device. The 8.3mm Polyester rope slipped at 4.3 kN and continued to slip. The 9mm HTP rope slipped at 8.5 kN for about 7 inches then started de-sheathing the rope. The 11mm Bluewater Nylon static rope did not slip at all and was finally pinched in two at 12 kN. The Safeguard device suffered no visible damage.
