Petzl GriGri+ Testing

Date: October 23, 2019

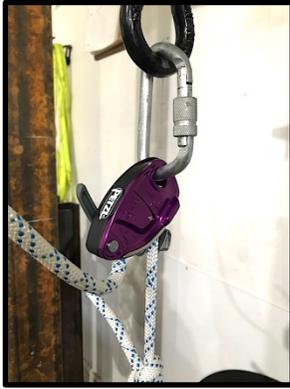
Configuration:

A new GriGri+ was connected via a carabiner to a dynamometer on the hydraulic cylinder of the break test machine. Selector knob on GriGri+ was placed in top-rope mode. Rope was threaded into GriGri+ with knotted bight anchored to the frame of the break test machine. Intent of the test was to measure the force required for various static ropes to slip through the GriGri+ device.
